Condition Assessment of the Antrim Grange No. 98

253 Clinton Road, Antrim, New Hampshire

Mae H. Williams, Preservation Consultant with Brian Gallien of Ironwood Restoration

Completed January 4, 2021

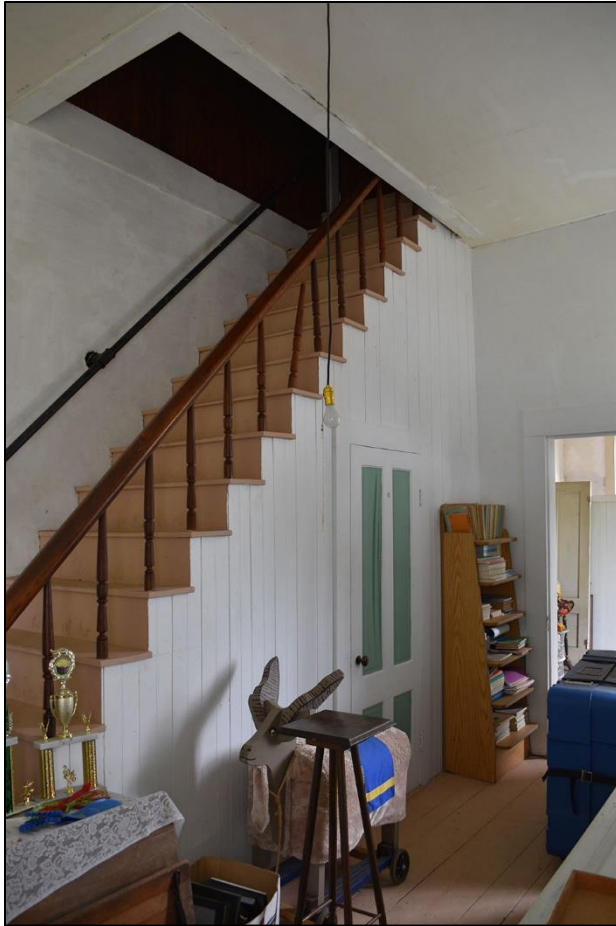
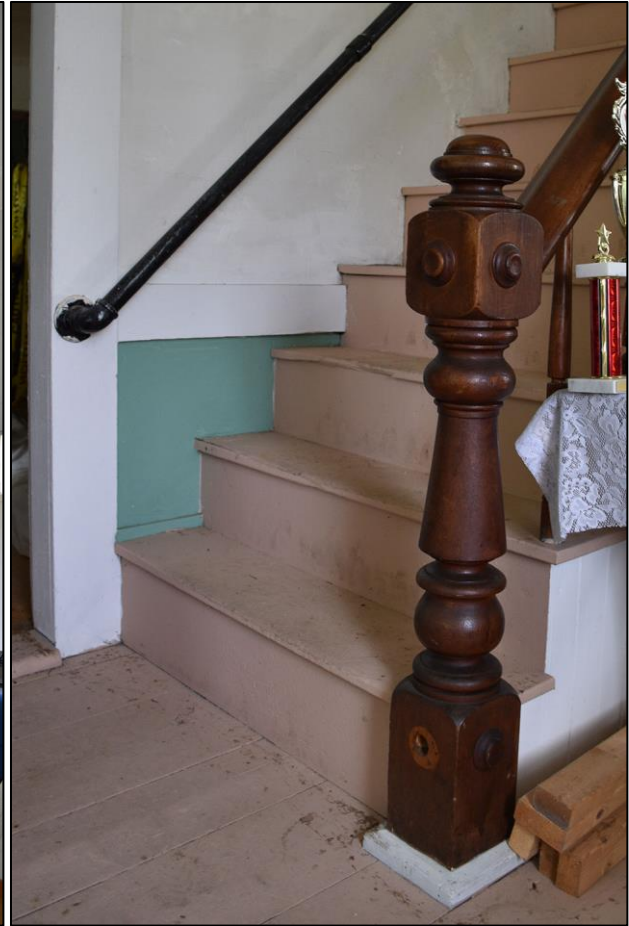
Generally, the reception room interior is in good condition, however there are significant condition issues relating to the stairs between the reception room and the second floor of the building. The stairs are extremely steep, and are entirely open to the attic with no fire-wall. Though the railing feels relatively sturdy, many of the balusters are missing, and there is damage to the base of the newel post (figures 30-31).

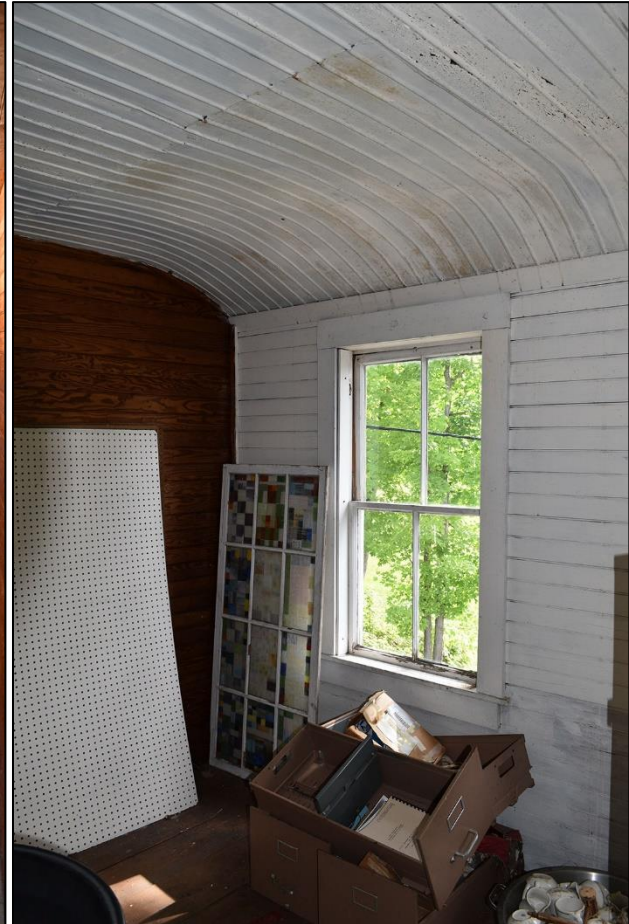
There is damage to the bead-board ceiling of the kitchen over the electric stove from historic roof leaks (figure 34). The interior surfaces are quite dingy, and the sink and stove are extremely dirty. The ever-present evidence of rodent activity strongly suggests that the stove would need to be fully restored (re-wired) prior to safe use. The gravity-fed water system is no longer working, and the north door opens into thin-air, creating a safety hazard.

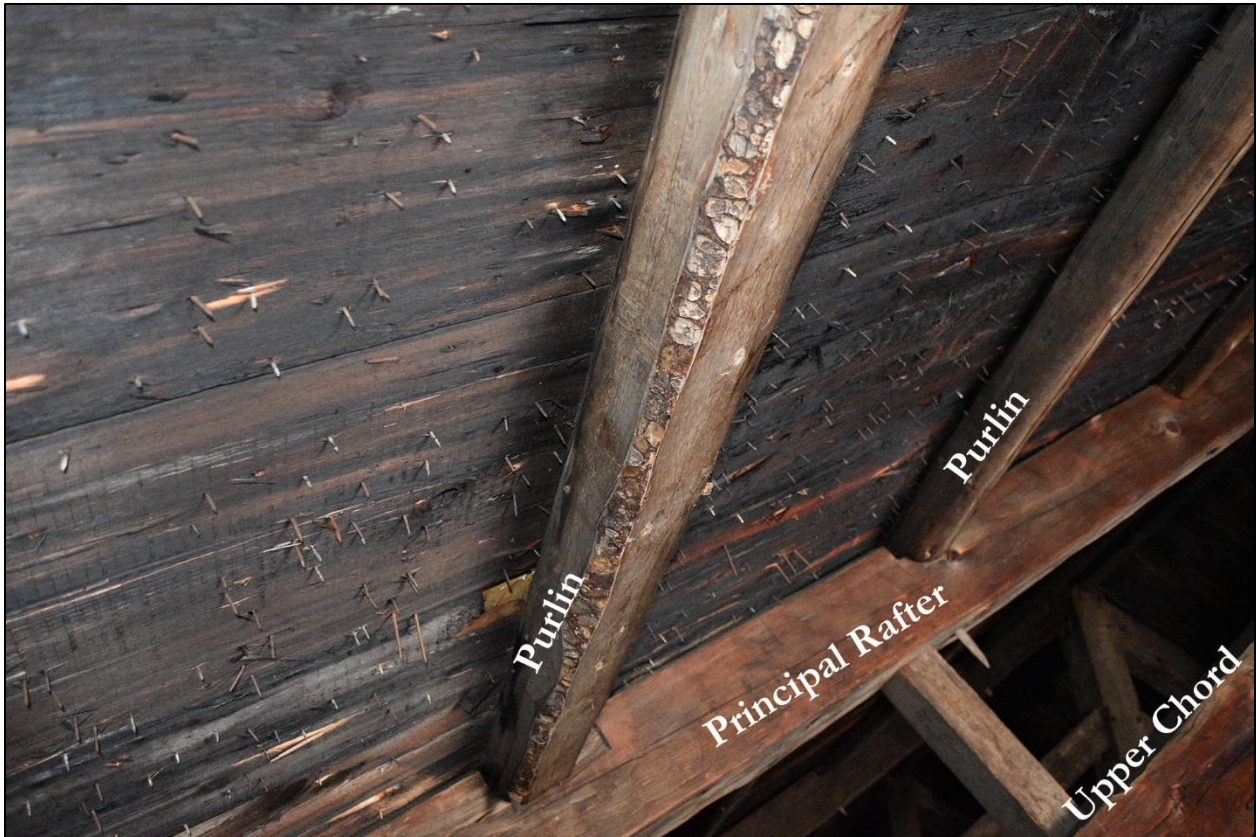
Figure 41: Detail of roof structure showing contrast between charred sawn sheathing boards and hand-hewn frame

The roof sheathing boards may be recycled from another building. Evidence of charring throughout the sheathing boards suggests that they were damaged by a fire (figure 41). There is no evidence of fire-damage to the frame itself. A modern layer of plywood was added between the historic sheathing boards and asphalt shingles in the 1990s when the roof was last replaced.

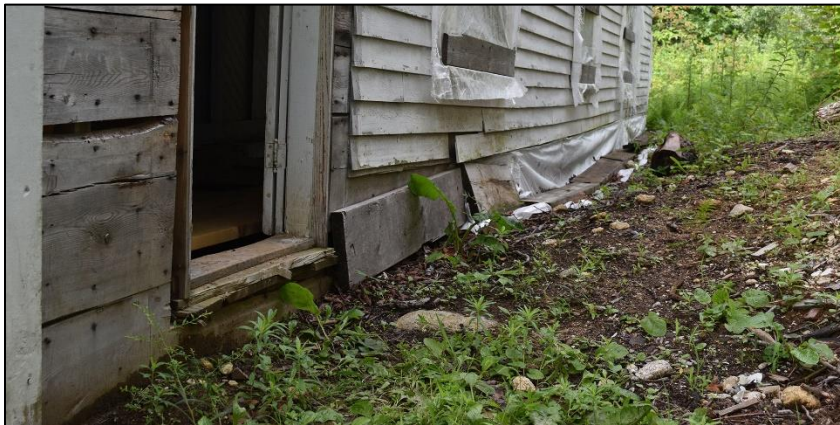
There are significant issues with the foundation and first-floor framing. The north bay of the Antrim Grange is on grade, and the lower framing and wall at this side of the building have disintegrated as a result of the constant contact with the damp ground (figure 43). The granite underpinning of the other sections of the building has shifted over time, and there are several stones that have tipped out of plumb (particularly at the southwest corner of the building, figure 44).

Figure 43: North sill

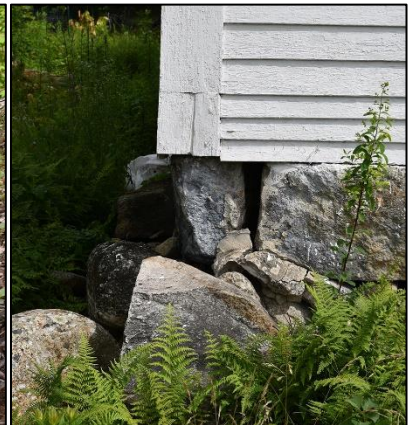
Figure 44: Foundation at SW corner

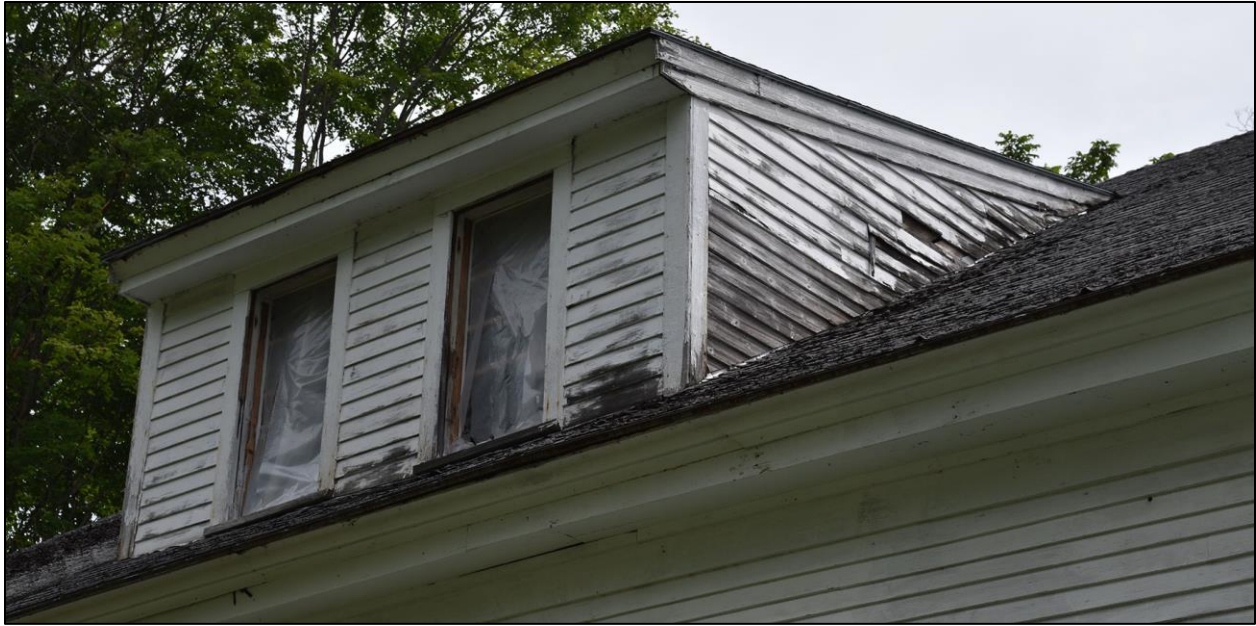
Figure 45: West roof slope and dormer window

The asphalt shingle roof of the Grange is in poor condition. There are several shingles missing near the ridge at the north end of the east slope, and there is some moss and lichen growth throughout this side of the roof. The shingles of the west slope are even more cupped and cracked. The intersection between each dormer and the asphalt shingle roof is marked by damp clapboards and biological growth, suggesting inadequate or failing flashing (figure 45).

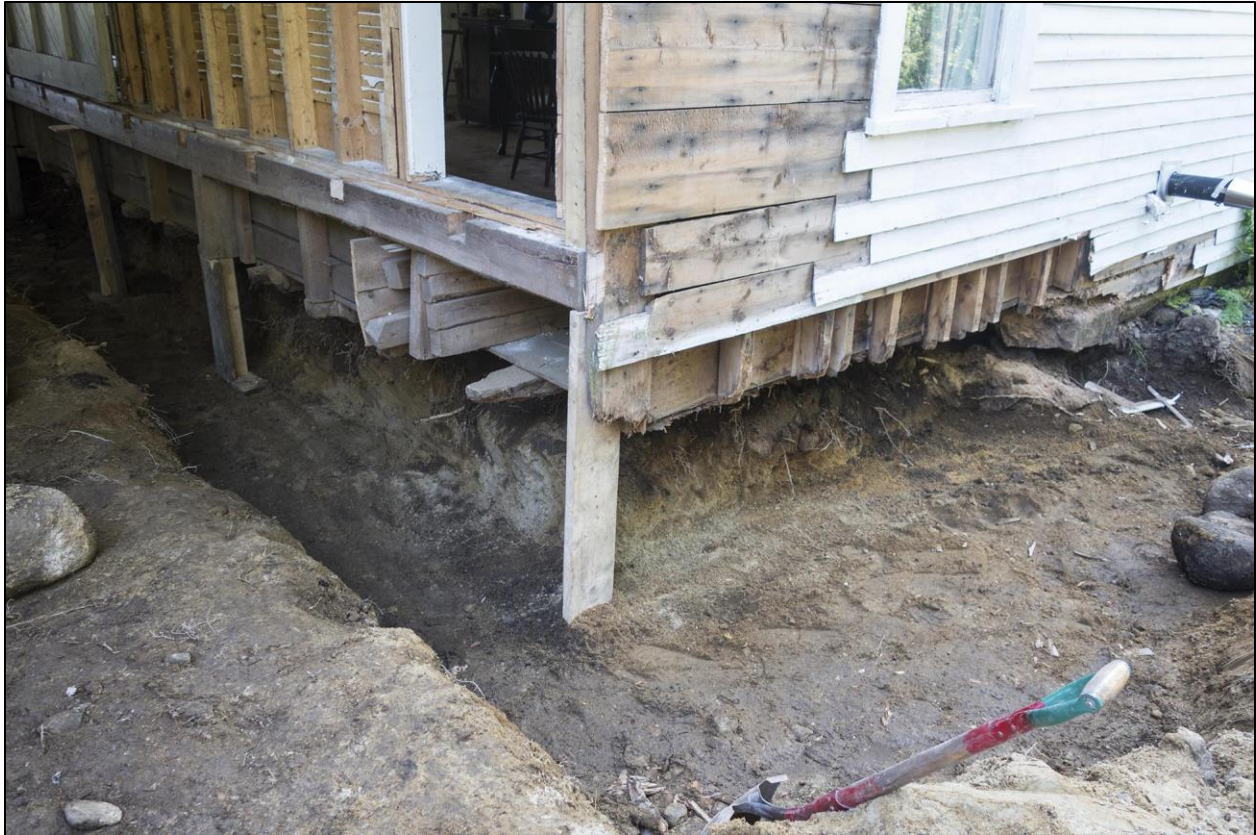
The exterior clapboards are in fair condition. There are areas of peeled paint throughout and several missing and split clapboards throughout the building exterior. A section of clapboards and adjacent trim is missing near the north door to the building, where the exterior sheathing is left uncovered (figure 46). Faint lines above the door indicate the gable roof above the door that once sheltered an outhouse at this location. This outhouse was removed in 2017 (the 2005 composting toilet is currently in storage). Of greater concern is the large opening at the northwest corner of the building that was cut away to provide access to the area beneath the backstage area during the ongoing sill-work (figure 47, the hole is currently covered with a tarp).

Figure 47: View looking down through the hole at northwest corner of the building, at the girt between hall and backstage area (Photo courtesy of Andras Lazar)

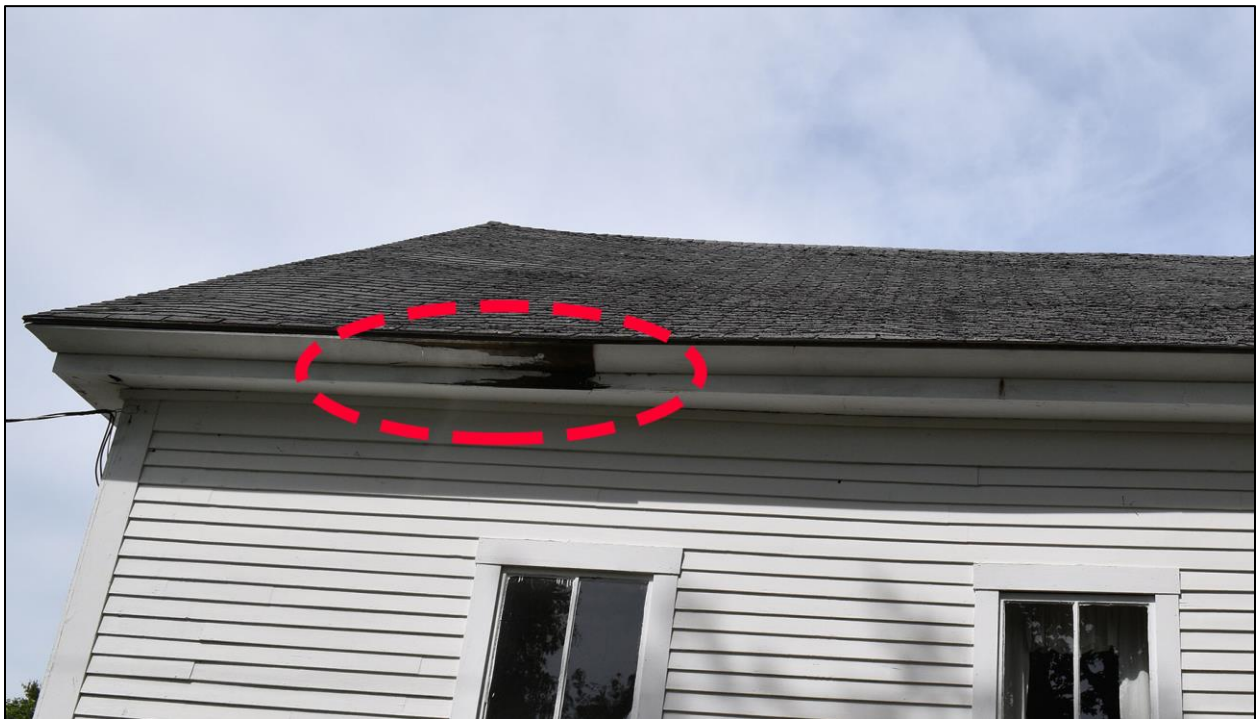
Figure 48: Hole in soffit at east elevation

The exterior building trim is somewhat damaged. Some of the historic character of the building was lost when large sections of the cornice were replaced with modern materials in a more simplified design. A section of the east soffit is loose (figure 48), and there are missing corner boards and window trim near the northwest corner of the building.

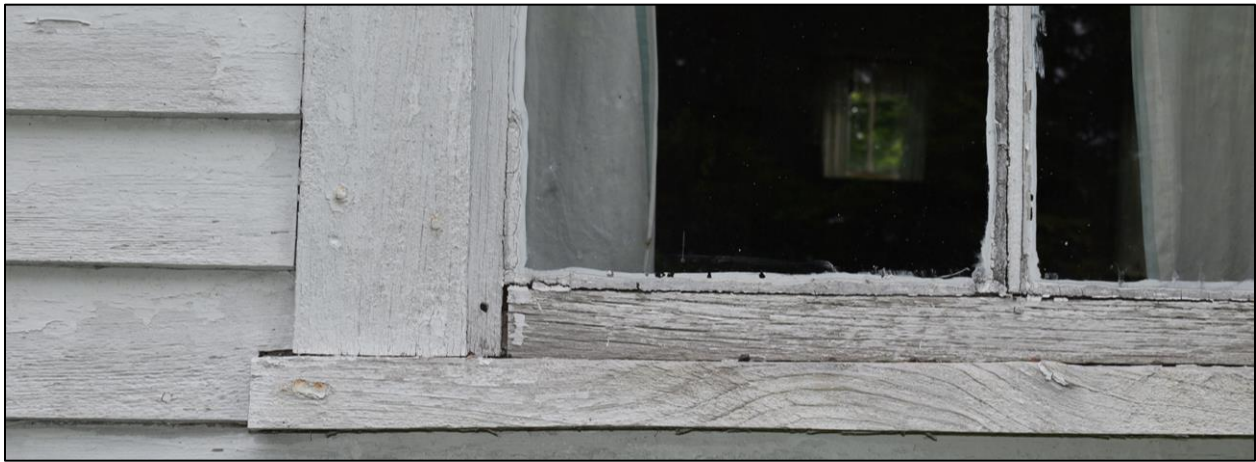
The historic windows are in fair to poor condition. Over time, some of the window sills, particularly on the west side of the building, have been replaced. Many of the sash were removed several years ago when a window restoration project was begun and have not been reinserted for fear of damage during the ongoing sill restoration. The empty window openings were temporarily covered with plastic sheeting, which is degrading rapidly and no longer adequately functioning to bar birds and animals from the building interior. The historic windows that remain in place have peeling paint and areas of loose and or missing glazing putty (figure 49). Fortunately, the wooden sash themselves appear to be in stable condition.

Figure 49: Detail of typical Grange window. This window, at the west side of the building, is assumed to have a replacement sill.

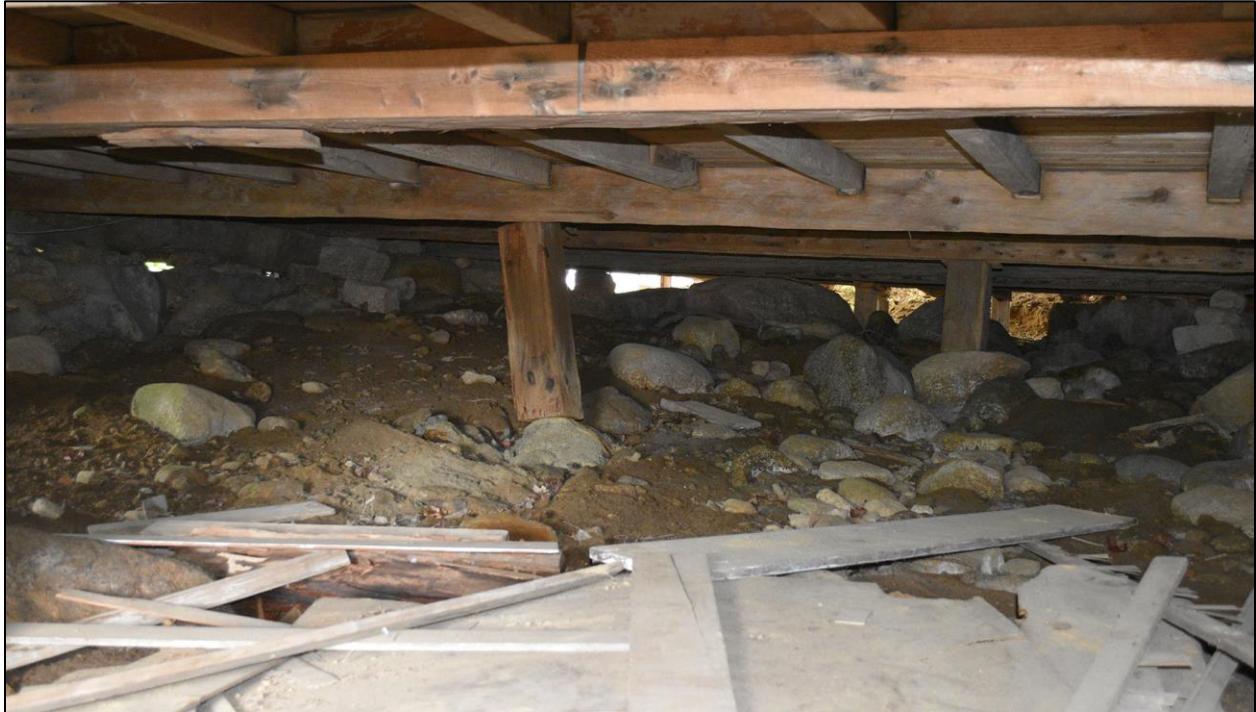
Crawlspace: As stated earlier, there are some major condition issues with the framing of the first-floor of the Antrim Grange. The north sill of the building is extremely rotten, as is the adjacent girder that runs beneath the edge of the stage, between the Lodge Room and backstage area. From within the crawlspace beneath the building, one can see that many of the original wooden support columns along the building interior are out of plumb or have toppled entirely (figure 50). Other supports that were placed directly onto the dirt beneath the building are rotten. There is a large amount of loose debris in the crawlspace, inhibiting air-flow, trapping moisture and encouraging ants/beetles, and other moisture-loving insects.

Figure 50: Crawlspace beneath Grange, facing north. Note debris in foreground and tipped wooden column near center of image

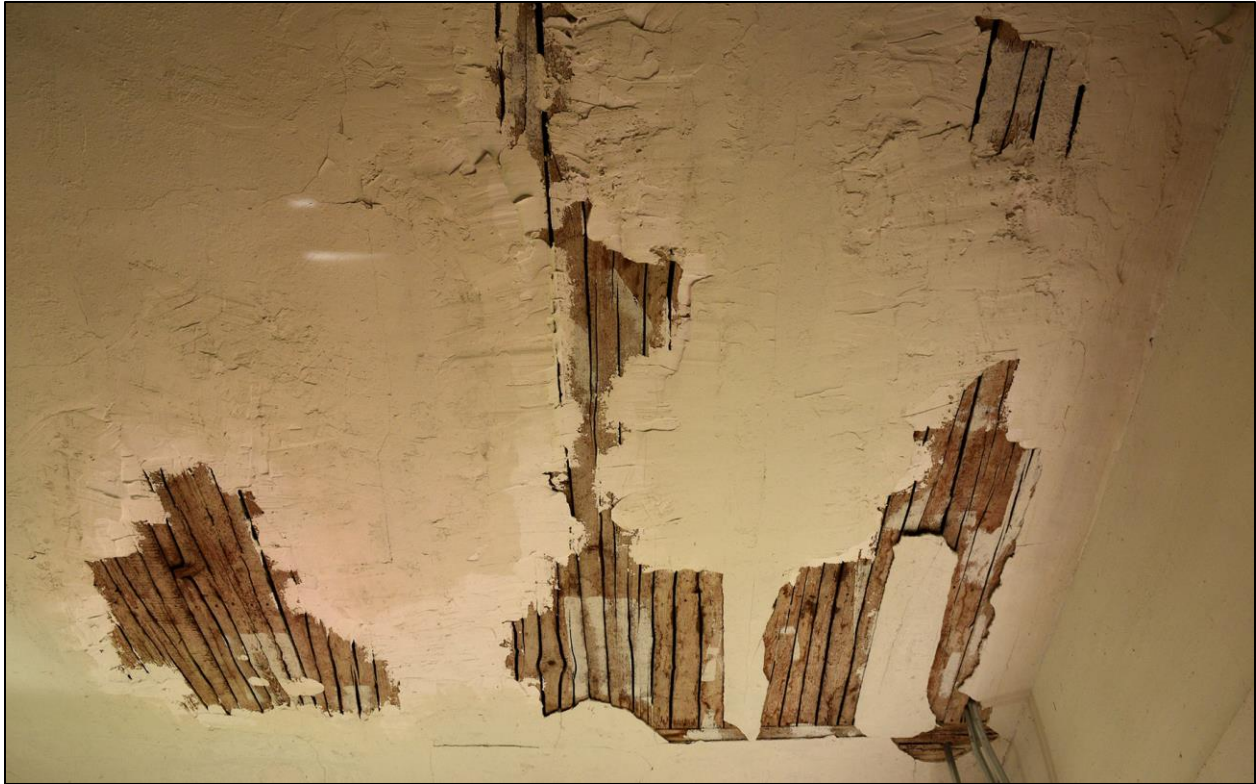
First Floor: The plaster surfaces of the interior of the Antrim Grange are in generally fair condition with some cracked and failing sections throughout. There are two areas of concentrated plaster damage: at the north wall of lodge room, where the building has been disturbed by the recent work on the structure below, and at the ceiling of the vestibule, directly above the building entrance (figure 51).

Figure 51: Exposed split lath at vestibule ceiling, facing east

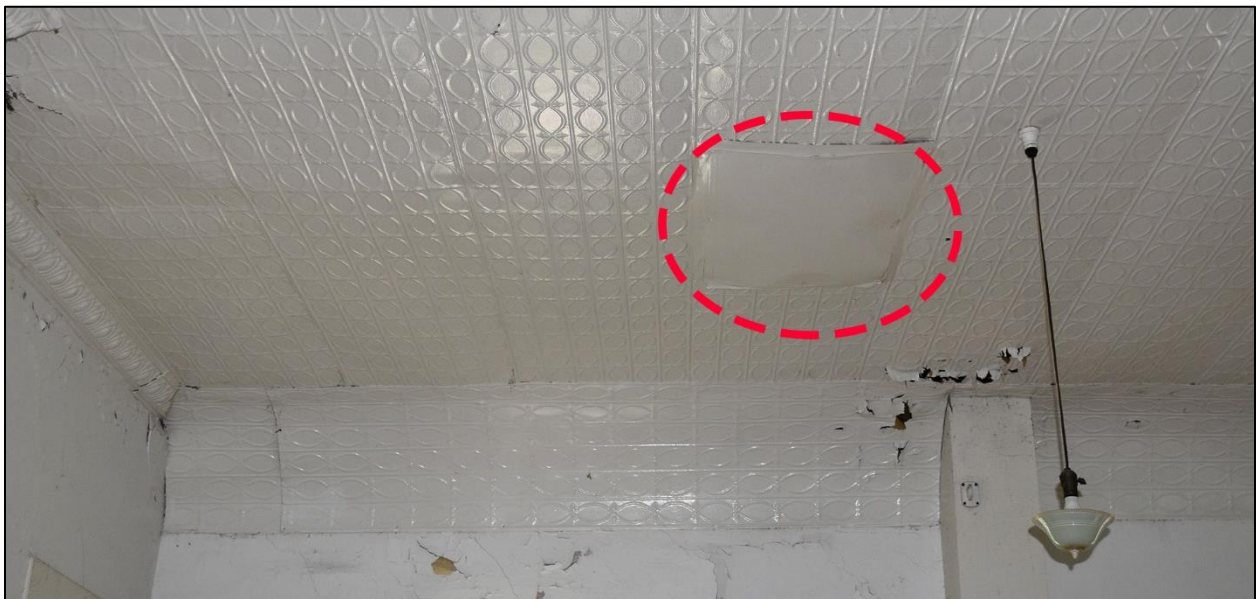
There is some damage to the metal ceiling of the Lodge Room. There are several areas throughout the ceiling where the original pressed metal is patched inappropriately with non-matching metal (figure 52). The painted surface is peeling throughout, and there is a large area that is patched with plastic where the chimney was recently removed at the north wall of the room. Much of the trim below the stage is missing.

Figure 52: Pressed metal ceiling, showing patch

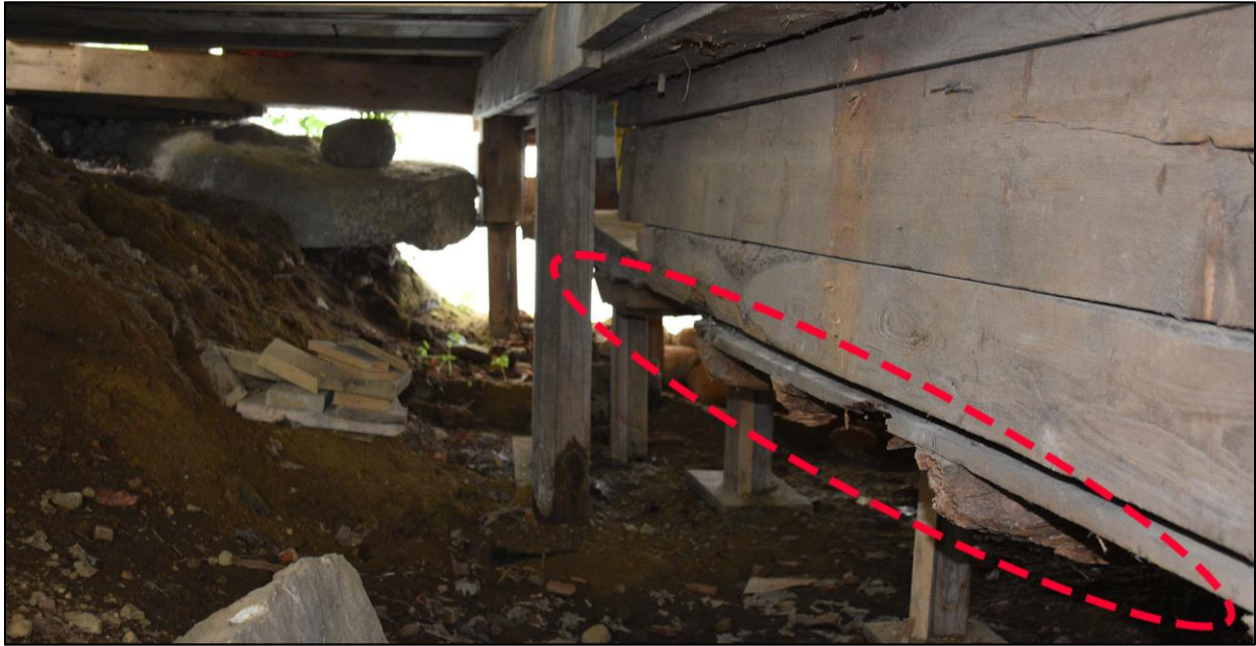
The backstage area has been completely stripped down to the studs. At present, the stairs between the lodge room and backstage area are removed, and access is along a very tenuous ramp. All of the interior plaster has been removed from the walls and ceilings of this space, and the entire flooring system was also removed. The west end wall of the room is also missing, and is covered by a sheet of plastic. From this space, one can clearly see the extent of the rot to the girder that runs beneath the stage (figure 53). The damage is so extensive that only small sections of the heavy timber remain at all. Damage to the north sill is also visible from this location. The north sill is split along the top, and has been sistered by several modern boards in an attempt to consolidate it (figure 54).

Figure 53: Crawlspace beneath backstage area, facing southeast and showing location of rotten girder

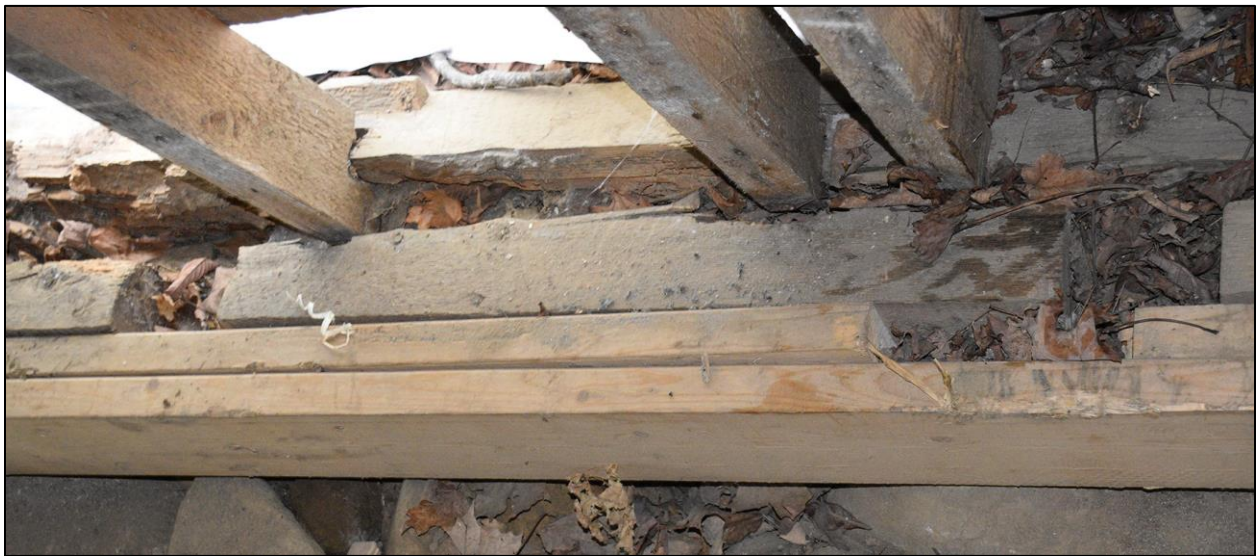
Figure 54: Badly deteriorated north sill of Grange with modern dimensional lumber attached to historic sill

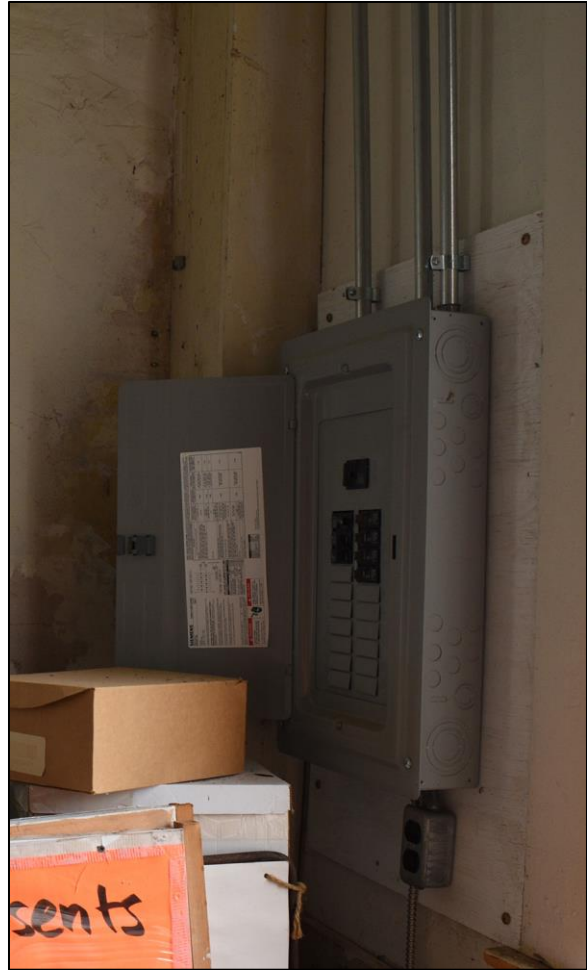
There is a relatively new electrical panel at the southeast corner of the building, within the vestibule area (figure 55). The modern panel has electrical breakers, and some of the older electrical circuits have been replaced with modern Romex. Much of the wiring within the building is knob-and-tube.

Figure 55: Electrical panel
