Gregg Lake Action Plan

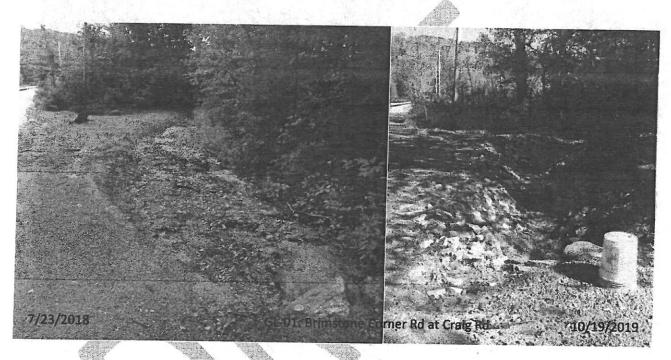
Figure 5.1. Erosion Site 01 at the intersection of Brimstone Corner Road, Craig Road and Gregg Lake Road, where stormwater runoff carries sediment down a steep section of Brimstone Corner Road and deposits it directly into Gregg Lake. Photos taken at the outlet of the culvert under Harbor Road looking towards Gregg Lake before (left) and after (right) installation of uphill turnouts and diversion dams, lining ditches, crowning, stabilizing road shoulders and installing a catch basin.

The main challenge to completing the Brimstone Corner Road project is scheduling Antrim Highway Department time. The Highway Department began work on the project in Fall 2019 (Fig. 5.1), and will continue in 2020.

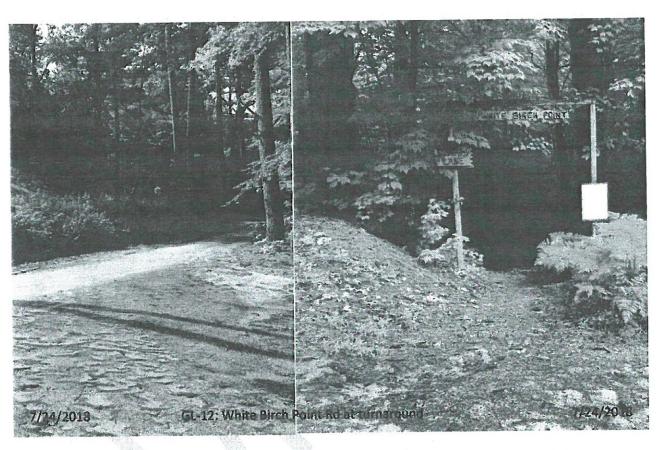
The Antrim Highway Department has assessed conditions on White Birch Point Road. Longstanding drainage issues mean that replacing deeply-buried culverts and rebuilding the road and ditches to improve drainage and direct runoff to catch basins will require major construction efforts.

Figure 5.2. Erosion Site 12, where stormwater runoff from the upper section of White Birch Point Road flows across the turnout (left) and enters the steep access road to the White Birch Point private beach (right) or an adjacent private driveway.

In Summer 2020, the White Birch Point Association will be approached regarding an easement for a catch basin. The Antrim Highway Department will schedule work to begin in 2022.

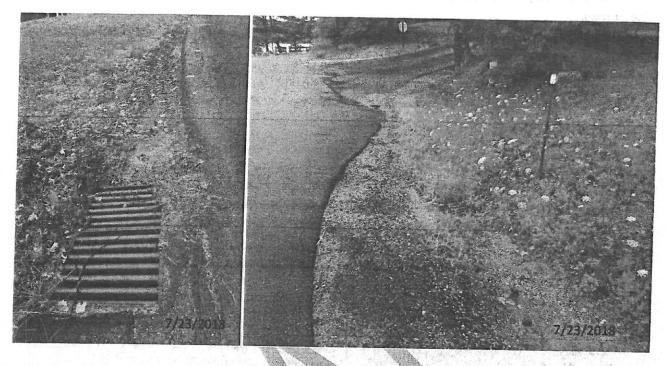
Figure 5.3. Erosion Site 09, where stormwater flows down Holt Hill Road, crosses Gregg Lake Road and washes across private beaches to enter Gregg Lake. A recently-constructed catch basin directs some of the flow under the road (left). Suggested area for installing a catch basin for remaining flow directed across Holt Hill Road, with storm drain in place (right). Ditch maintenance will be increased as needed to retain sediment.

In addition to stabilizing the road shoulder and armoring ditches, the recommendation from our consulting engineers (HWG) is to install a water bar to divert remaining water flow from South Holt Hill Road into an infiltration basin on the east side of the road. There may be adequate space to install a catch basin within the road right-of-way. If not, an easement from the land owner may have to be sought. Runoff will be monitored to see how much private beach erosion continues to take place. Further work on Holt Hill Road will be scheduled to begin in 2025.

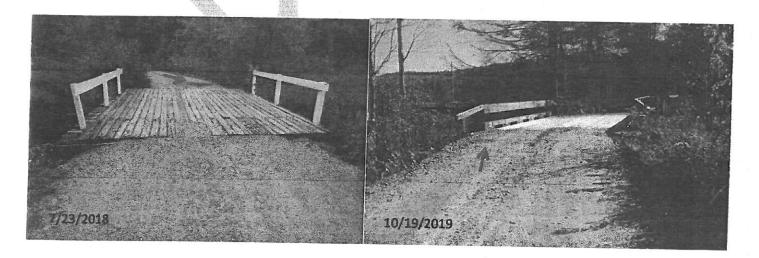
At the time of the initial survey in July, 2018, severe erosion was evident around the Craig Road Bridge (Fig. 5.4). Water levels were also high due to beaver dams under both the Craig Road bridge and the Gregg Lake Road bridge. A sinkhole had opened up near the north side of the bridge in 2018. The Craig Road bridge was replaced in Spring 2019. An additional erosion site was identified at the intersection of Hattie Brown Road and Craig Road.

Figure 5.4. Left: Erosion Site 06 viewed from the south, showing severe erosion of Craig Road causeway and bridge shoulders, high water level on west (left) side of bridge due to beaver dam underneath and location of filled sinkhole, which had opened up in 2018 (arrow). Right: Site 06 viewed from the north, after bridge replacement. Sinkhole location still visible (arrow).

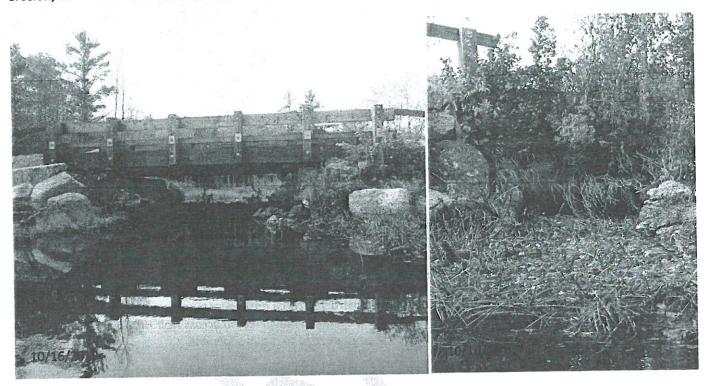
It is likely that high water levels have caused stress on both sides of the Craig Road causeway, as evidenced by sinkholes and shoulder erosion. The beaver dam under the Craig Road bridge was removed for construction of the new bridge, but the beavers had begun to rebuild by mid-summer (Fig. 5.5). Given the sinkhole formation and shoulder and bank erosion, beaver control devices should be installed under the Craig Road bridge to minimize the rise of water levels.

Figure 5.5. Beaver dam under new Craig Road bridge (left), with downstream water level lowered by approximately 16 inches after removal of flash boards at Gregg Lake dam. Bank erosion and probable sinkhole drainage site (arrow) at high water level made visible by low water level.

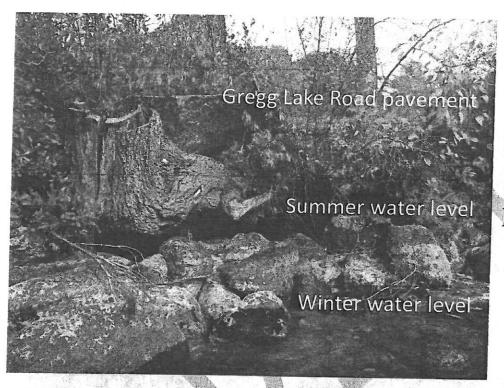
Since the Gregg Lake dam was rebuilt in 1982, the lake level has been kept consistently higher than it ever was in the past. Erosion in many areas shows that a new shoreline is being established. This erosion is severe for a stretch of about 2,000 feet along Gregg Lake Road, where in several spots the bank undercut at the summer water level reaches close to, if not under, the road pavement (Fig. 5.6). The land on the lake side of the road from near the dam to the public beach is privately owned.

Figure 5.6. Undercut of bank close to Gregg Lake Road at summer water level. Photo taken with water at winter level, with both flash boards removed and water just flowing over dam.

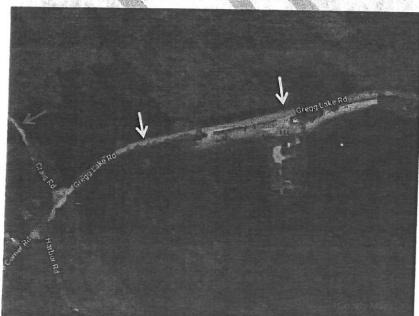
Gregg Lake Road Causeway (Causeway, 1.7 lb/yr phosphorus load; bridge, 0.6 lb/yr) The causeway stretch of Gregg Lake Road crosses what used to be a mowed wet meadow (Fig. 5.7). It appears that the causeway was first constructed around 1835, when the Gregg Lake dam was located at the mouth of the current outlet channel and lake water levels were several feet lower. Records of repairs and improvements are scant, and the composition of the causeway foundation is not known.

Figure 5.7. Overhead view of the causeway stretch of Gregg Lake Road, including the Town Beach and Boat Launch area. Arrows show locations of sinkholes that opened up along Gregg Lake Road (yellow) and Craig Road (red) in 2018.

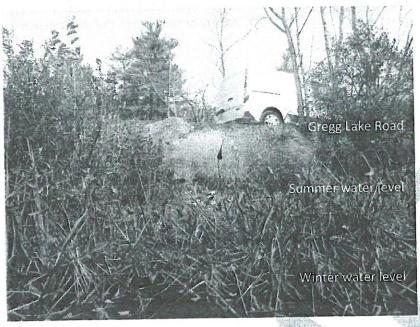
High water levels due to beaver dams, combined with the higher water levels maintained since the Gregg Lake dam was rebuilt in 1982, have led to unprecedented strain on both sides of the causeway. The lower sections of the steep banks on the south side of the causeway are eroding due to wave and water action (Fig. 5.8).

Figure 5.8. Loss of vegetation and erosion at steep causeway bank, visible at winter water level.

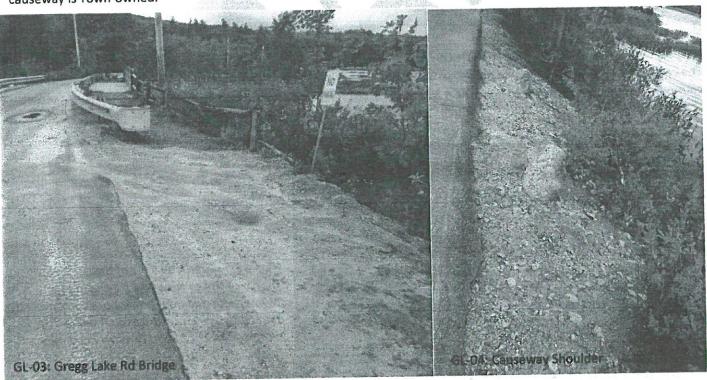
In addition, the shoulders require reinforcement and revegetation along much of the 1,300-foot causeway (Fig. 5.9). Private property borders the eastern 900 feet of the causeway on the north side; the rest of the property bordering the causeway is Town-owned.

Figure 5.9. Erosion Sites 03 and 04, showing bare shoulders and erosion of steep banks leading directly into Gregg Lake.

Our engineering consultants, Horsley-Witten Group (HWG) suggested stabilizing the banks along Gregg Lake Road with a wall of Gabion baskets (wire cages filled with rocks). This approach would be very difficult to achieve, considering that the land on the lake side of Gregg Lake Road is privately owned except along the causeway.

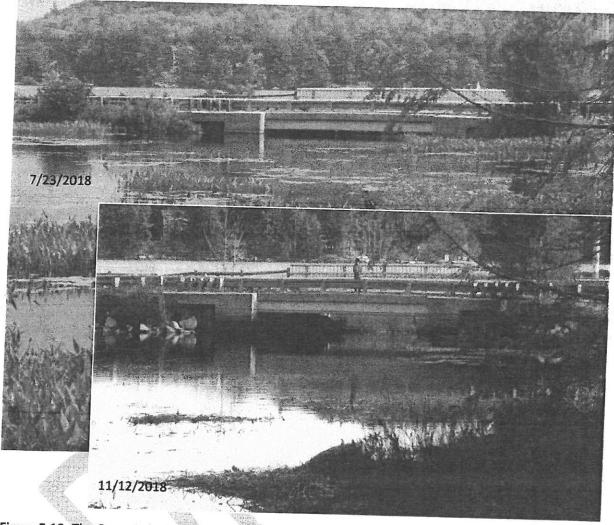
Beaver dams constructed under the Gregg Lake Road bridge have regularly filled the space under the bridge (Fig. 5.10). In 2018, the water was measured to be more than two feet higher on the northern (upstream) side than the summer lake level on the southern (downstream) side, and reached several inches over the bottom of the bridge.

Figure 5.10. The Gregg Lake Road bridge with the water on the north side of the beaver dam nearly touching the bottom of the bridge in Summer 2018, and in Fall 2018, following removal of the beaver dam.

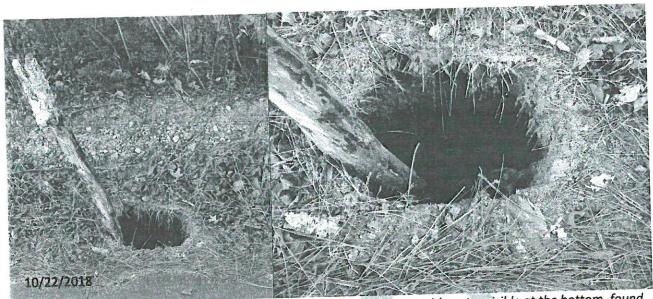
In 2018, two sinkholes opened up on the north side of the causeway (locations shown in Fig. 9). One was likely at least partly responsible for a town truck falling into the water—the causeway shoulder collapsed when the truck tires left the pavement as two town trucks tried to pass each other. The second sinkhole was observed approximately a month after truck incident (Fig. 5.11).

Figure 5.11. Sinkhole approximately 3 feet in diameter and 3 feet deep, with water visible at the bottom, found on Gregg Lake Road causeway Fall 2018.

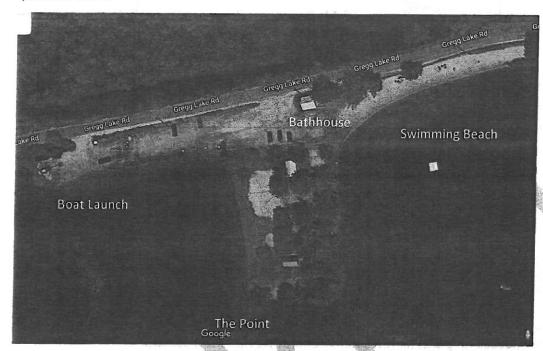
Figure 5.12. Antrim Town Beach and Boat Launch area.

The Antrim Town Beach and boat launch areas (Fig. 5.12) are heavily used. Banks are eroding, vegetation has been worn away and stormwater drains across the sand into the lake in several areas (Fig. 5.13). The boat launch has receded as sand has been carried into the lake (Fig. 5.14). Engineering suggestions are to stabilize the boat ramp with permeable pavers, revegetate the area, set aside no-mow areas and install swales and rain gardens to capture runoff. In addition, it is likely that the septic holding tanks are the original tanks installed in the 1960s. The tanks should be inspected and decisions made regarding the need for replacement with a similar setup or an alternative, such as a composting toilet or portable toilets.

Much of the remediation work to be done at the Beach and Boat Launch areas can be performed by volunteers and/or town employees. Funding will be needed for plants for revegetation efforts, signage and materials.

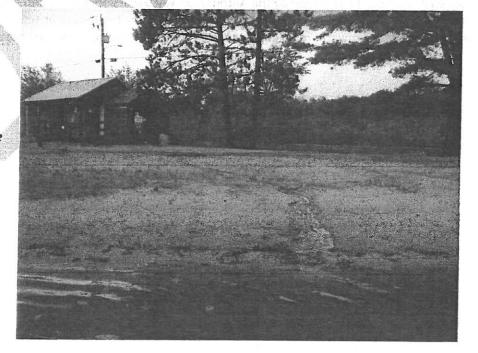
Figure 5.13. Drainage from Gregg Lake Road and the beach parking lot across the beach into Gregg Lake.

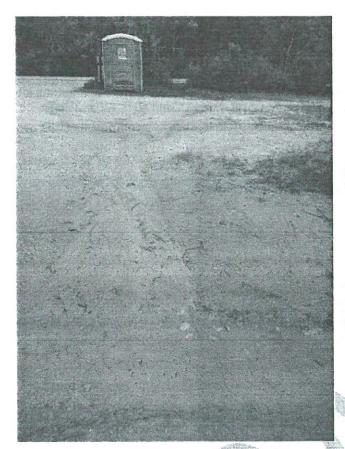
Figure 5.14. Stormwater flow down the public boat ramp into Gregg Lake.

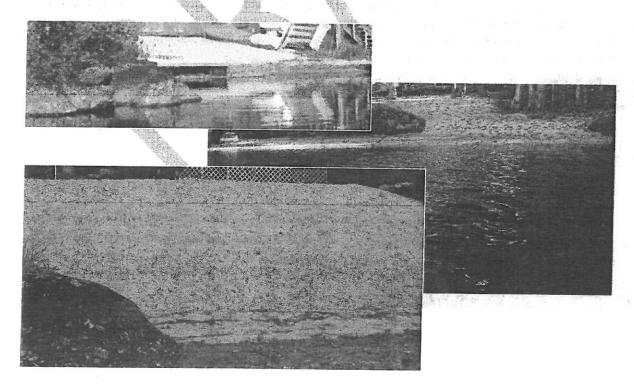
Although shoreline surveys did not identify many severe erosion sites, there were several sites where practices do not adhere to shoreline protection guidelines, especially in the areas of dumping sand to create beaches and clearing vegetation from areas close to the shoreline. One site visible from Gregg Lake Road, where sand was dumped on the steep bank leading down to the shoreline, was rated by FBE as contributing 1.7 lb/yr of phosphorus and nearly 2 tons/yr of sediment loading (Fig. 6.1). Two analogous additional sites were found during the Fall 2019 shoreline survey, for a total phosphorus load of approximately 5.1 lb/yr—a substantial fraction of Gregg Lake's phosphorus load that could be reduced through landowner education.

Figure 6.1. Severe erosion sites where sand has been dumped recently to create beaches on Gregg Lake.

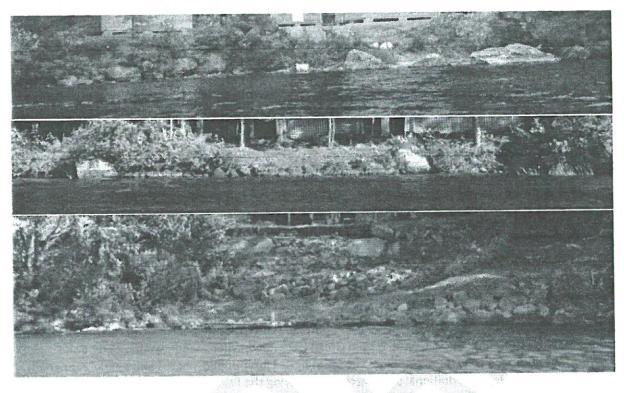
There have also been several recent instances in which vegetation has been cleared to the shoreline (Fig. 6.2). Education to reach shoreline landowners about the effects of these practices on lake phosphorus and suspended sediments due to erosion and stormwater runoff should help to reduce the frequency of such practices.

Figure 6.2.
Examples of recent clearing, exposing shoreline to erosion at Gregg Lake.

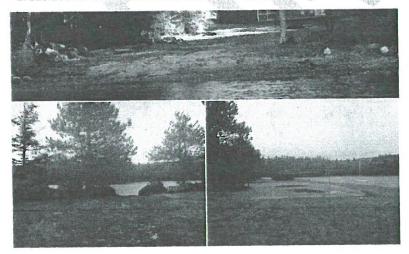
Figure 6.3. Lawn areas at Gregg Lake.

There are not too many properties around the perimeter of Gregg Lake with extensive areas of lawn, and few of these are treated with fertilizers or pesticides. However, shoreline property owners, including the Town of Antrim, will be encouraged to decrease expanses of lawn to make the lake less attractive to geese and limit erosion (Fig. 6.3). Lawn areas at the Town Beach are worn bare and eroding.

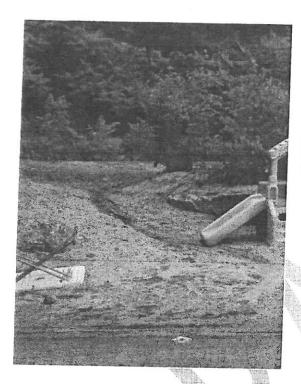
Many sites of erosion due to stormwater runoff are found around the lake shoreline (Fig. 6.4). A combined effort with the Town installing BMPs to reduce runoff from roads and private landowners managing land runoff and drainage from impervious surfaces will be required to achieve the necessary reductions in phosphorus and sediment.

Figure 6.4. Erosion Site 11, where runoff from Holt Hill Road flows across a private beach, carrying phosphorus and sediment into Gregg Lake.

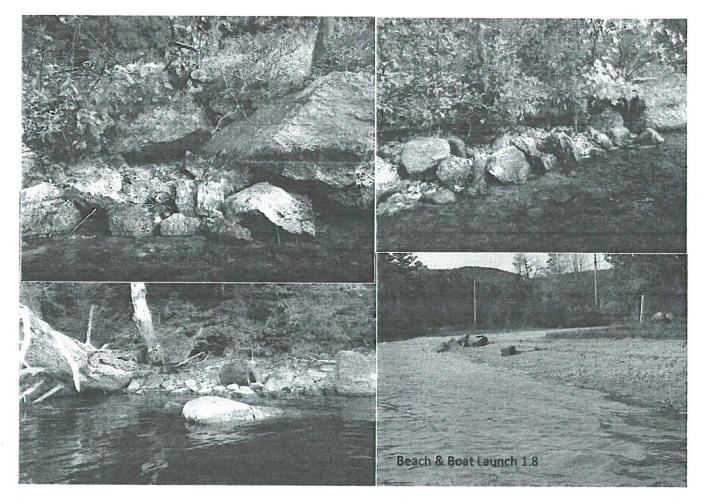
Since then, the dam has been operated with two 8" flashboards, and the lake has been establishing a new shoreline, with severe erosion along steep banks and recession of the shoreline in shallower areas (Fig. 8.2). Erosion along the steep banks of a 2,000-foot stretch of Gregg Lake Road is reaching a critical point, where the bank has been undercut in some places as much as three feet deep, reaching close to or under the road pavement (see Fig. 5.6). Wave and boat wake action at summer water level exacerbates the undercutting.

Figure 8.2. Shoreline erosion on Gregg Lake, visible at winter water level.

As a first step towards managing the erosion along Gregg Lake Road and the causeway, we propose lowering the summer lake level by 12", by replacing the two 8" flashboards currently in use with a single 4" flashboard. Lowering the lake by this amount will pull the water back from the steep banks in most locations, with wave energy dissipated against rocky or sandy bottom rather than continuing to cut away higher on the banks. This will limit the shoreline erosion evident all around the lake and give private landowners along Gregg Lake Road a start at managing shoreline erosion on their properties. We have been advised by NHDES that since the Town owns the dam, the Select Board would have to approve a change in the summer water level. Leaving a 4" flashboard in place allows release of water, if needed, since we are not currently able to operate gates at the dam.
