Condition Assessment of the Antrim Grange No. 98

253 Clinton Road, Antrim, New Hampshire

Mae H. Williams, Preservation Consultant with Brian Gallien of Ironwood Restoration

Completed January 4, 2021

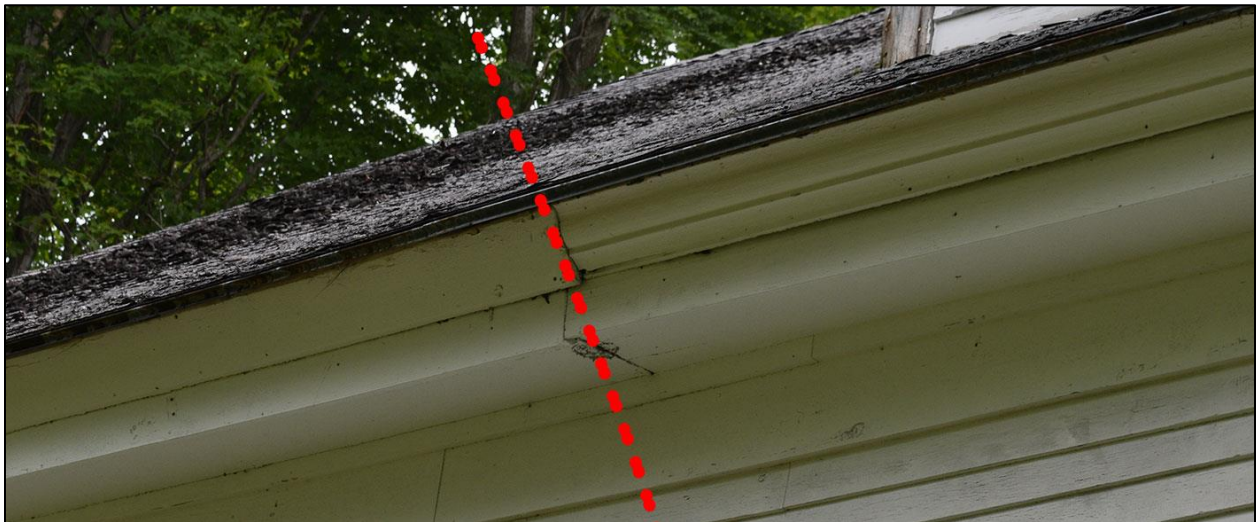
Figure 13: Eave detail showing modern flat "shingle molding" at left and molded historic "shingle molding" at right

The eaves of the Grange are boxed. The current building has a flat frieze board with square bed molding, flat soffit and flat fascia. The majority of the shingle molding is replaced with a simple flat board, set at an approximately 45° angle (figure 13). A small section of the original shingle molding survives at the southwest corner of the building. The building likely once had a wide Greek Revival-style frieze board with simple molded bed molding in addition to the shingle molding. These eave details were likely quite damaged by the time of the emergency roof repairs in the 1990s and were replaced with the simplified details as part of the roof repair. The boxed eaves continue around the southeast and southwest corners of the building, creating simple returns at the primary façade. The eaves at the north end of the building are close, with no overhang or returns. The lack of detail at the rear of the building is likely original to the construction of the addition.

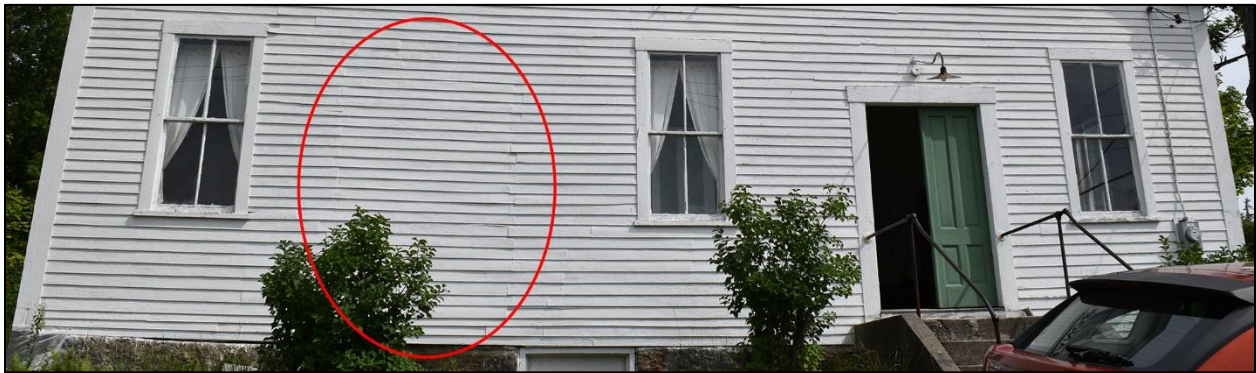
Figure 14: South elevation, showing location of historic second door

The primary entrance to the building is through the southeast corner. A set of concrete steps with pipe-rail (inscribed 1919) lead to a pair of four-panel doors. Markings in the clapboards indicate that there was once a second, matching, entrance at the southwest corner of the building (figure 14). Paired entries would be typical of a nineteenth-century public building, and it is likely that the second entry was removed by the Grange shortly after they gained ownership of the building. A secondary entrance is located along the east side of the building, near the northeast corner of the building (figure 15). A single concrete step leads to a four-panel door at this location. A third entry is located at the north elevation.

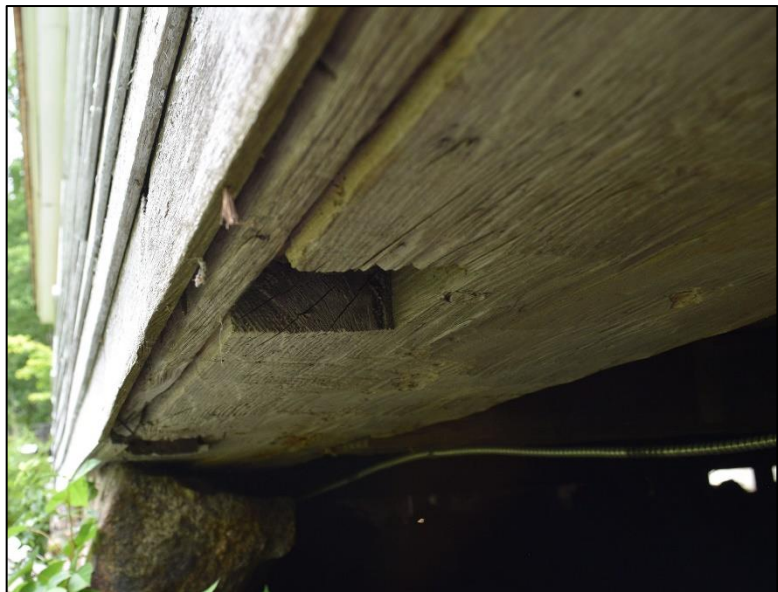
Figure 17: Underside of sill near southwest corner of building with empty mortise

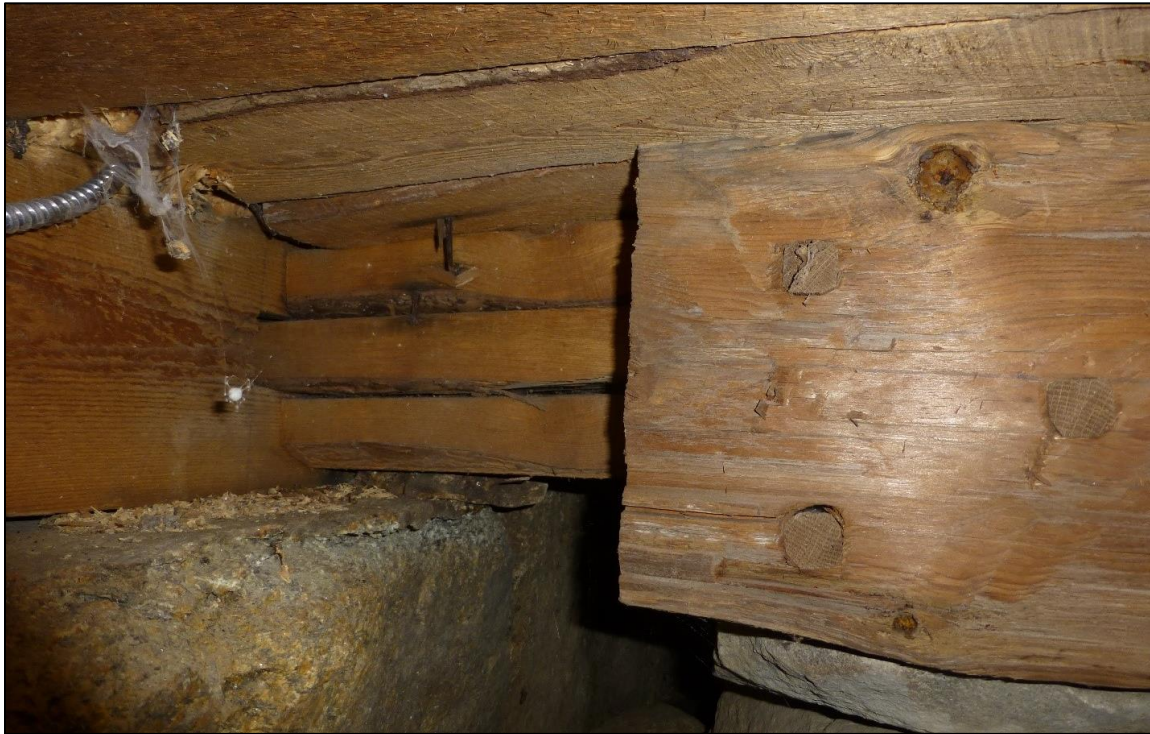
rocks. One of the girders has been “stretched” or extended to accommodate the existing span by mortising in sawn dimensional stock into the end of the timber and held in place with pegs. One of the pieces of stock is then tenoned into the west sill (figure 18).

Figure 18: Board stretcher at the intersection of a first-floor girder (or carrying timber) and west sill

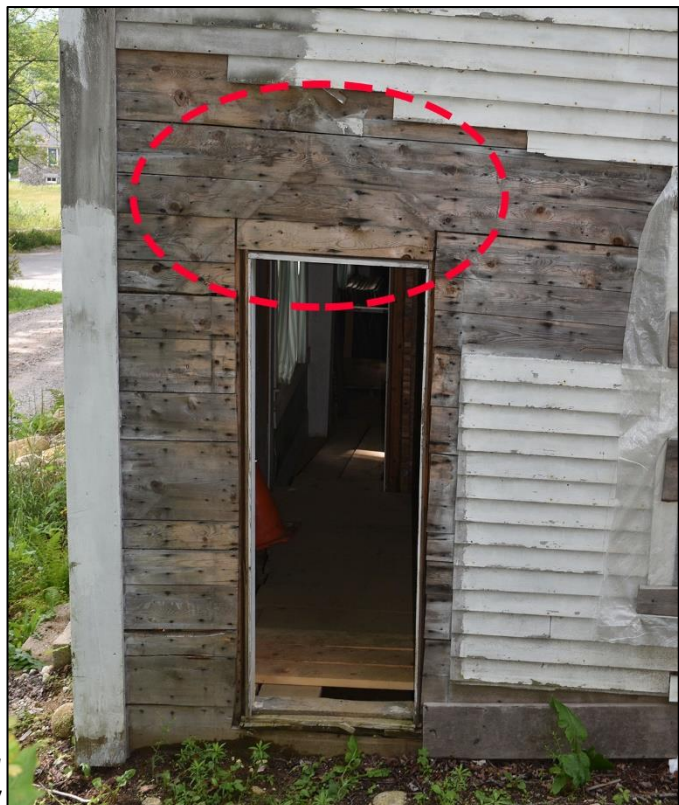
The exterior clapboards are in fair condition. There are areas of peeled paint throughout and several missing and split clapboards throughout the building exterior. A section of clapboards and adjacent trim is missing near the north door to the building, where the exterior sheathing is left uncovered (figure 46). Faint lines above the door indicate the gable roof above the door that once sheltered an outhouse at this location. This outhouse was removed in 2017 (the 2005 composting toilet is currently in storage). Of greater concern is the large opening at the northwest corner of the building that was cut away to provide access to the area beneath the backstage area during the ongoing sill-work (figure 47, the hole is currently covered with a tarp).

Figure 46: North entrance with ghosting showing historic hood above doorway
