Gregg Lake Action Plan

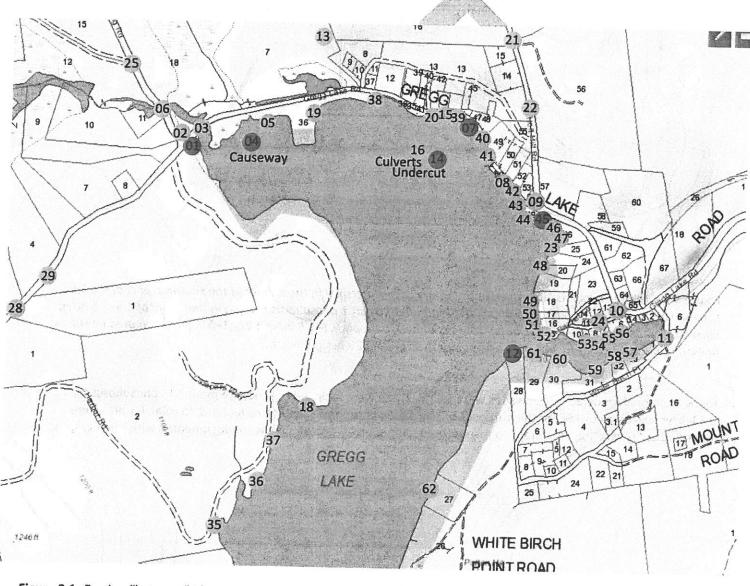
Two additional sites comparable to "severe" sites identified earlier were found. Since these were sites where loads of sand had been dumped on private beaches, these sites were assigned the same phosphorus loading values as the previously-identified beach where sand had been dumped. It should be noted that FBE recommended using an average phosphorus loading value of 4.4 lb/yr for severe sites not visible for evaluation from public roads. However, since our top-ranking erosion sites fell only in the range of 1.5–2.5 lb/yr, phosphorus loading values for comparable sites were used.

Figure 3.1. Erosion "hotspots" identified in the Gregg Lake watershed in the vicinity of the northern part of the lake. Locations classified as "severe" (red dots) were estimated to cause phosphorus loading in the range of 1.5–2.5 lb/yr, whereas "moderate" sites (orange dots) were estimated to supply 0.1–1.5 lb/yr. Sites 1–31 were evaluated by FBE for pollutant loads; sites 32–63 were rated by comparison with FBE's assignments.

Many additional moderate erosion sites were found. These were assigned the average moderate phosphorus load of 0.44 lb/yr suggested by FBE for the purposes of calculating phosphorus loading reductions. In total, 63 sites were identified as "severe" or "moderate" phosphorus loading sources, and all sites were documented with photographs.

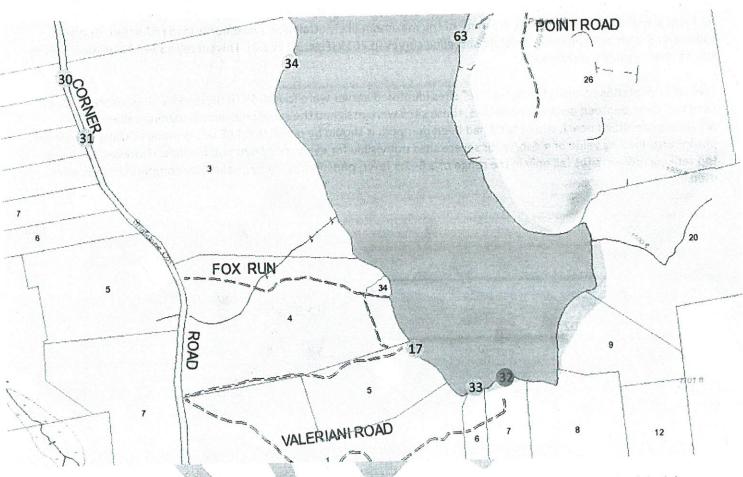
Figure 3.2. Erosion "hotspots" identified in the Gregg Lake watershed in the vicinity of the southern part of the lake. Locations classified as "severe" (red dots) were estimated to cause phosphorus loading in the range of 1.5–2.5 lb/yr, whereas "moderate" sites (orange dots) were estimated to supply 0.1–1.5 lb/yr. Sites 1–31 were evaluated by FBE for pollutant loads; sites 32–63 were rated by comparison with FBE's assignments.

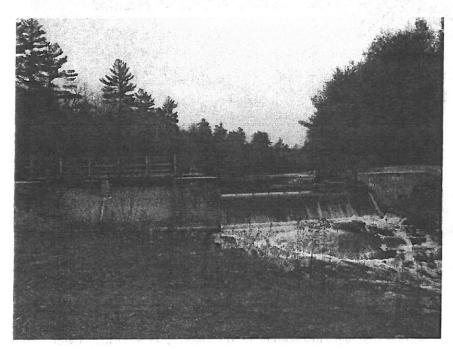
When the Gregg Lake dam was replaced in 1982 (Fig. 8.1), the water level was raised substantially above historical levels. The new dam was built to be used with three 8" flashboards in place in the summer months, but the third flashboard was quickly removed due to complaints that the water level was too high.

Figure 8.1. Gregg Lake dam, rebuilt in 1982, with no flashboards in place.

Since then, the dam has been operated with two 8" flashboards, and the lake has been establishing a new shoreline, with severe erosion along steep banks and recession of the shoreline in shallower areas (Fig. 8.2). Erosion along the steep banks of a 2,000-foot stretch of Gregg Lake Road is reaching a critical point, where the bank has been undercut in some places as much as three feet deep, reaching close to or under the road pavement (see Fig. 5.6). Wave and boat wake action at summer water level exacerbates the undercutting.

Our efforts for the next few years will focus on clearly posting, educating and enforcing the current boating regulations on Gregg Lake, along with lowering the lake water level by one foot. If, after a few years of lake water quality monitoring, these measures are not considered adequate for reaching phosphorus loading reduction goals, we will move to petition the state to reduce the horsepower limit and work towards introducing a bill to the NH State Legislature to increase the no-wake zone to 500 feet (Fig. 8.4), as recommended by FBE.
